Case 297 : Narrative

Case Vehicle (A): 1999 Ford	Veh. (B): 1998 Chevrolet
Type: Escort ZX2, 2-door coupe	Type: Tracker, 4 x 4, 2-door convertible SUV
Driver: 49- year-old female	Driver: 49- year-old female
CDC: 12-FDEW-2	CDC: 02-RYEW-2

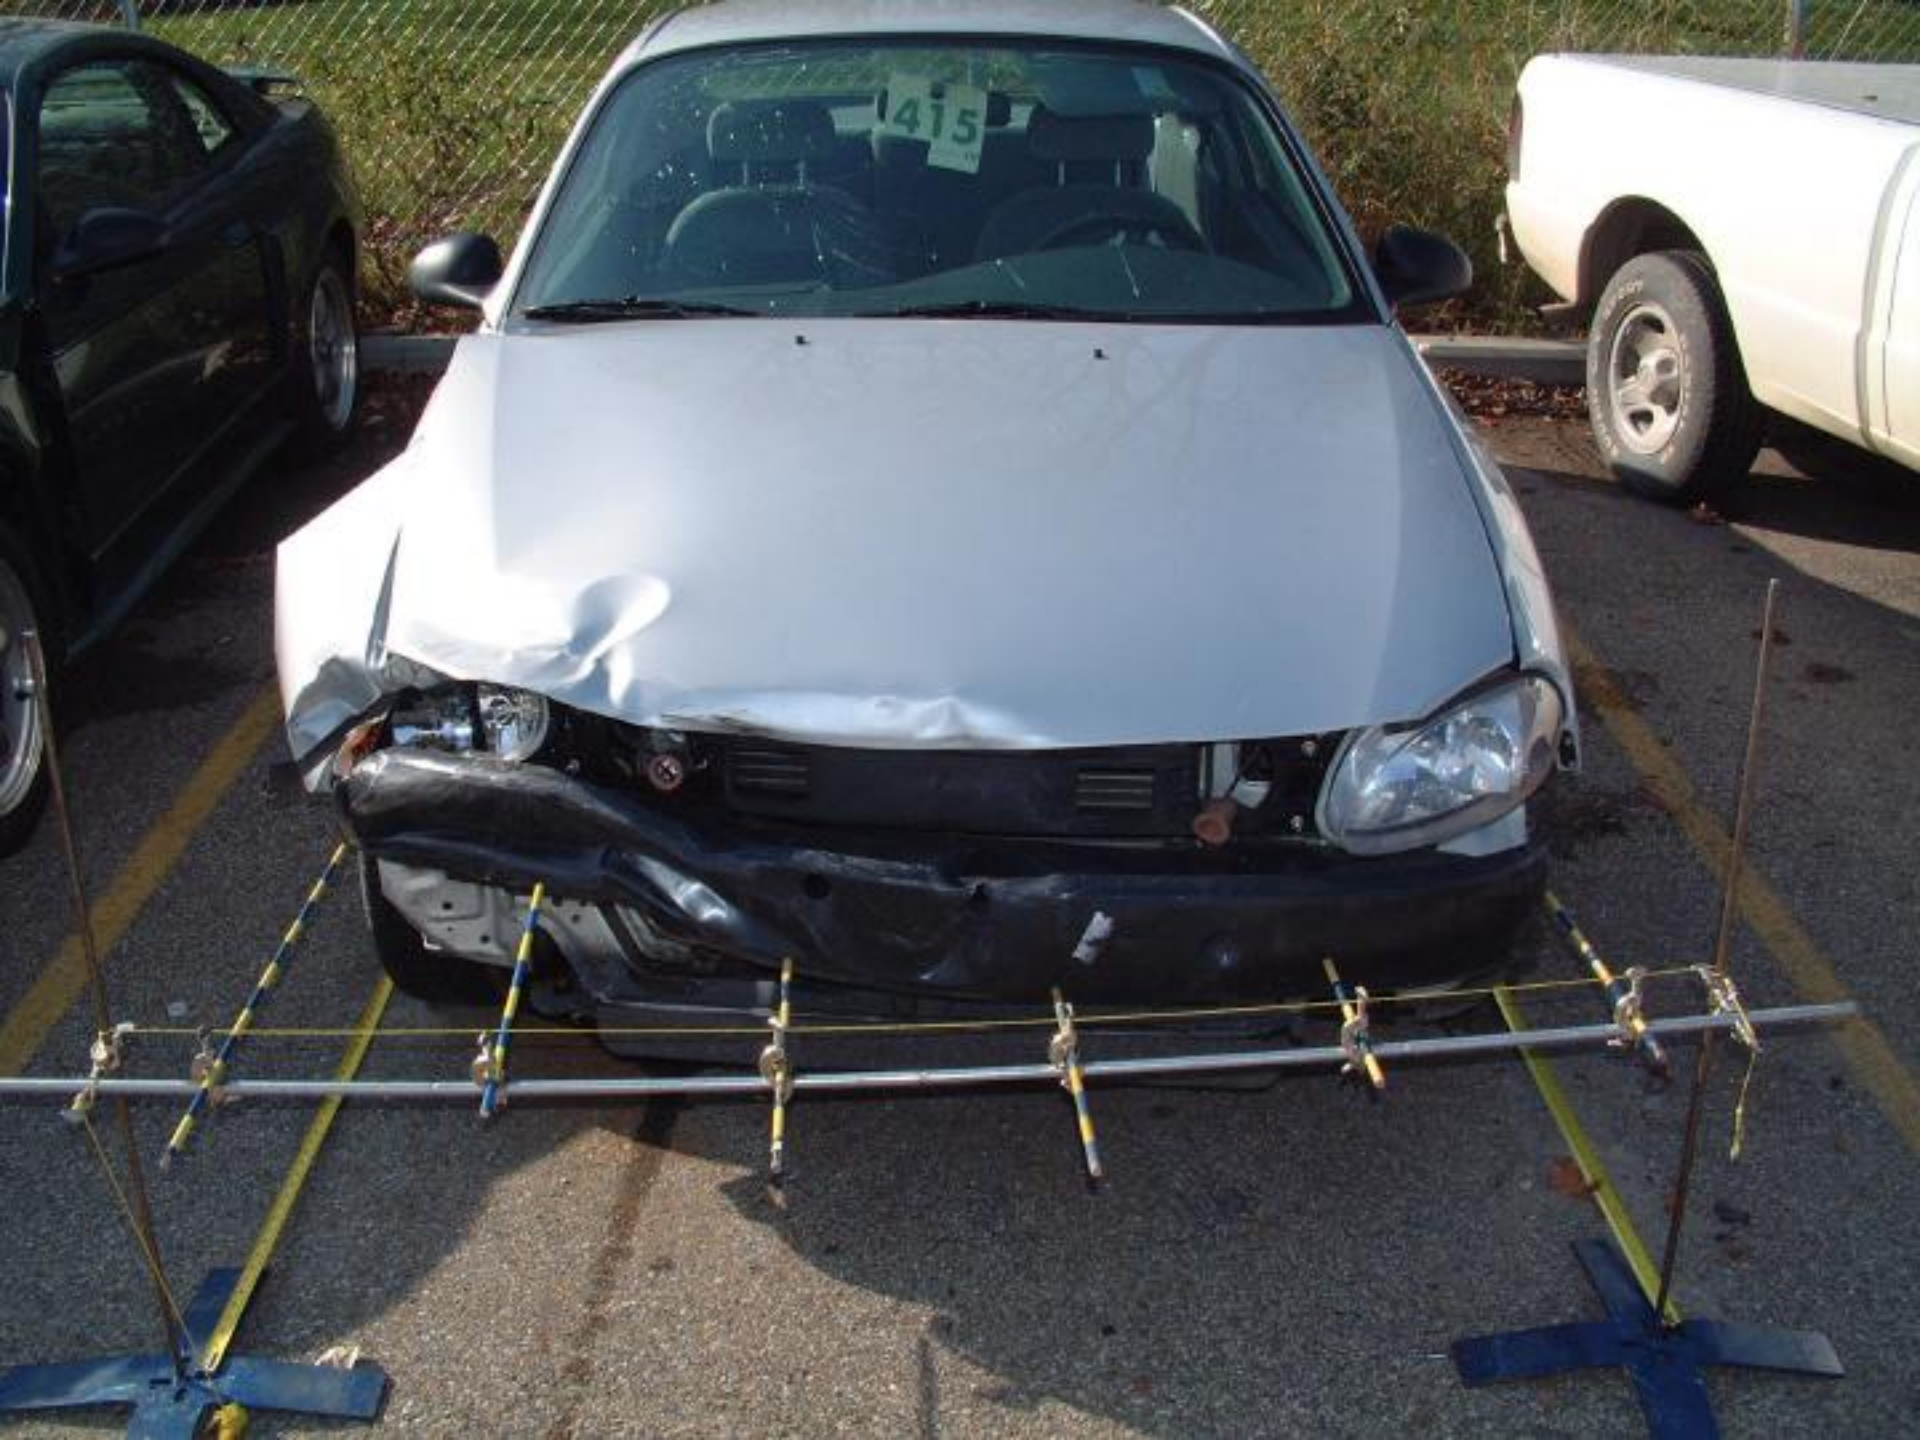
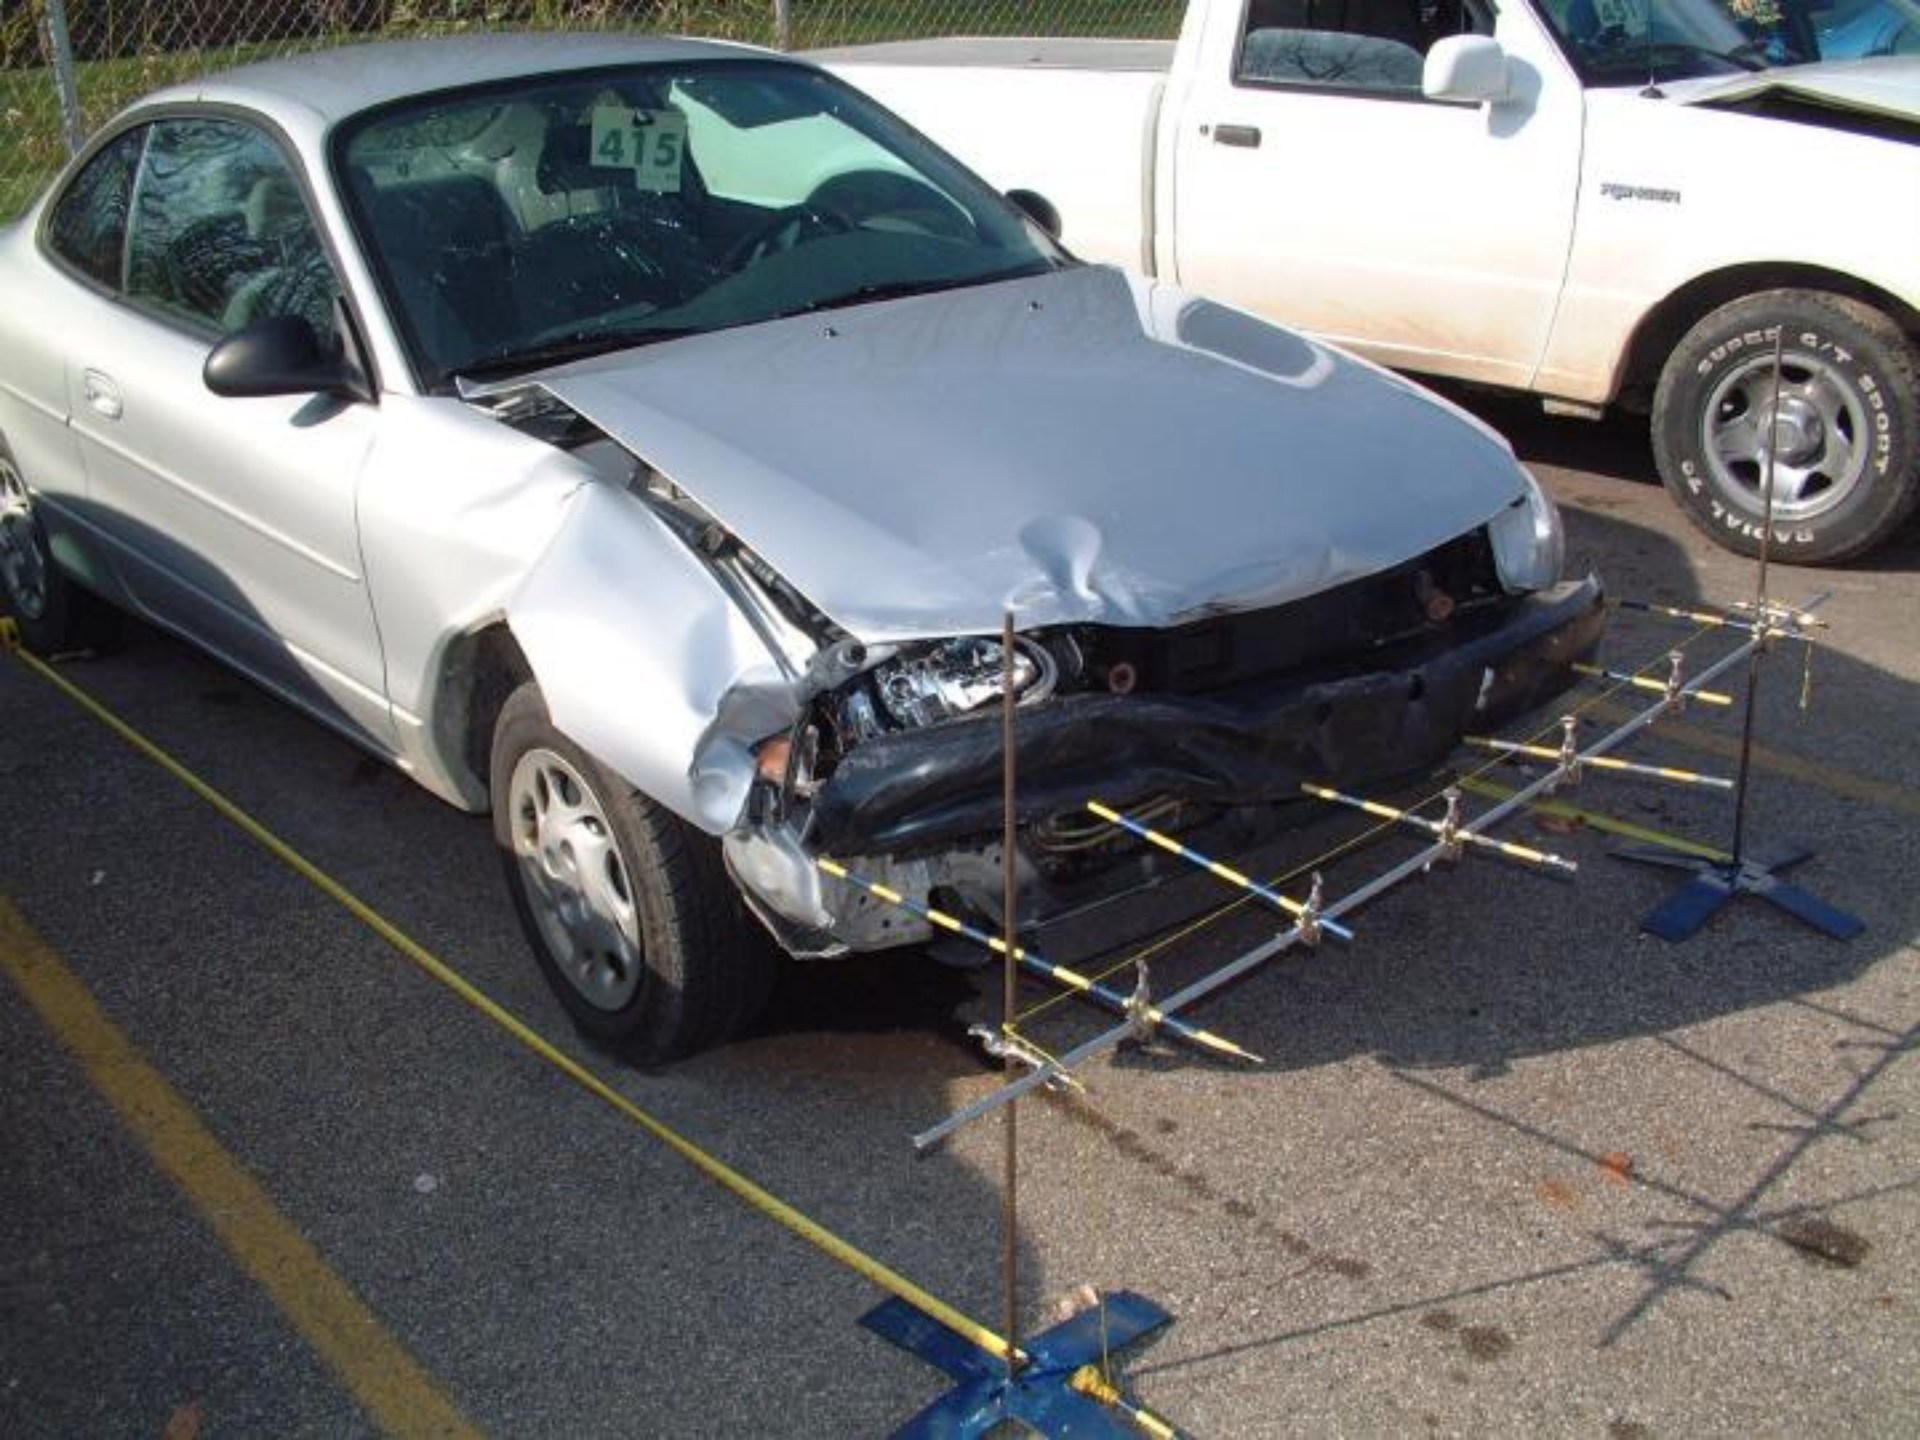
This vehicle was equipped with steering-wheel and passenger frontal-impact airbags, and [31](#) [32](#) [33](#) both deployed. [34](#) [35](#) [36](#) The lower cover/flap of the steering-wheel airbag module was slightly bowed inward, possibly from contact with the driver's arm. [37](#) The cover/flap of the passenger airbag module was slightly bowed inward from [38](#) contacting and cracking the windshield. [39](#) [40](#) There were no deformations of the steering-wheel rim or spokes, [41](#) but there was a scuffmark on the upper section of the steering-wheel rim. [42](#) There was also a scuffmark on the knee bolster cover. [43](#) [44](#) [45](#) There were no intrusions and no other interior damage.

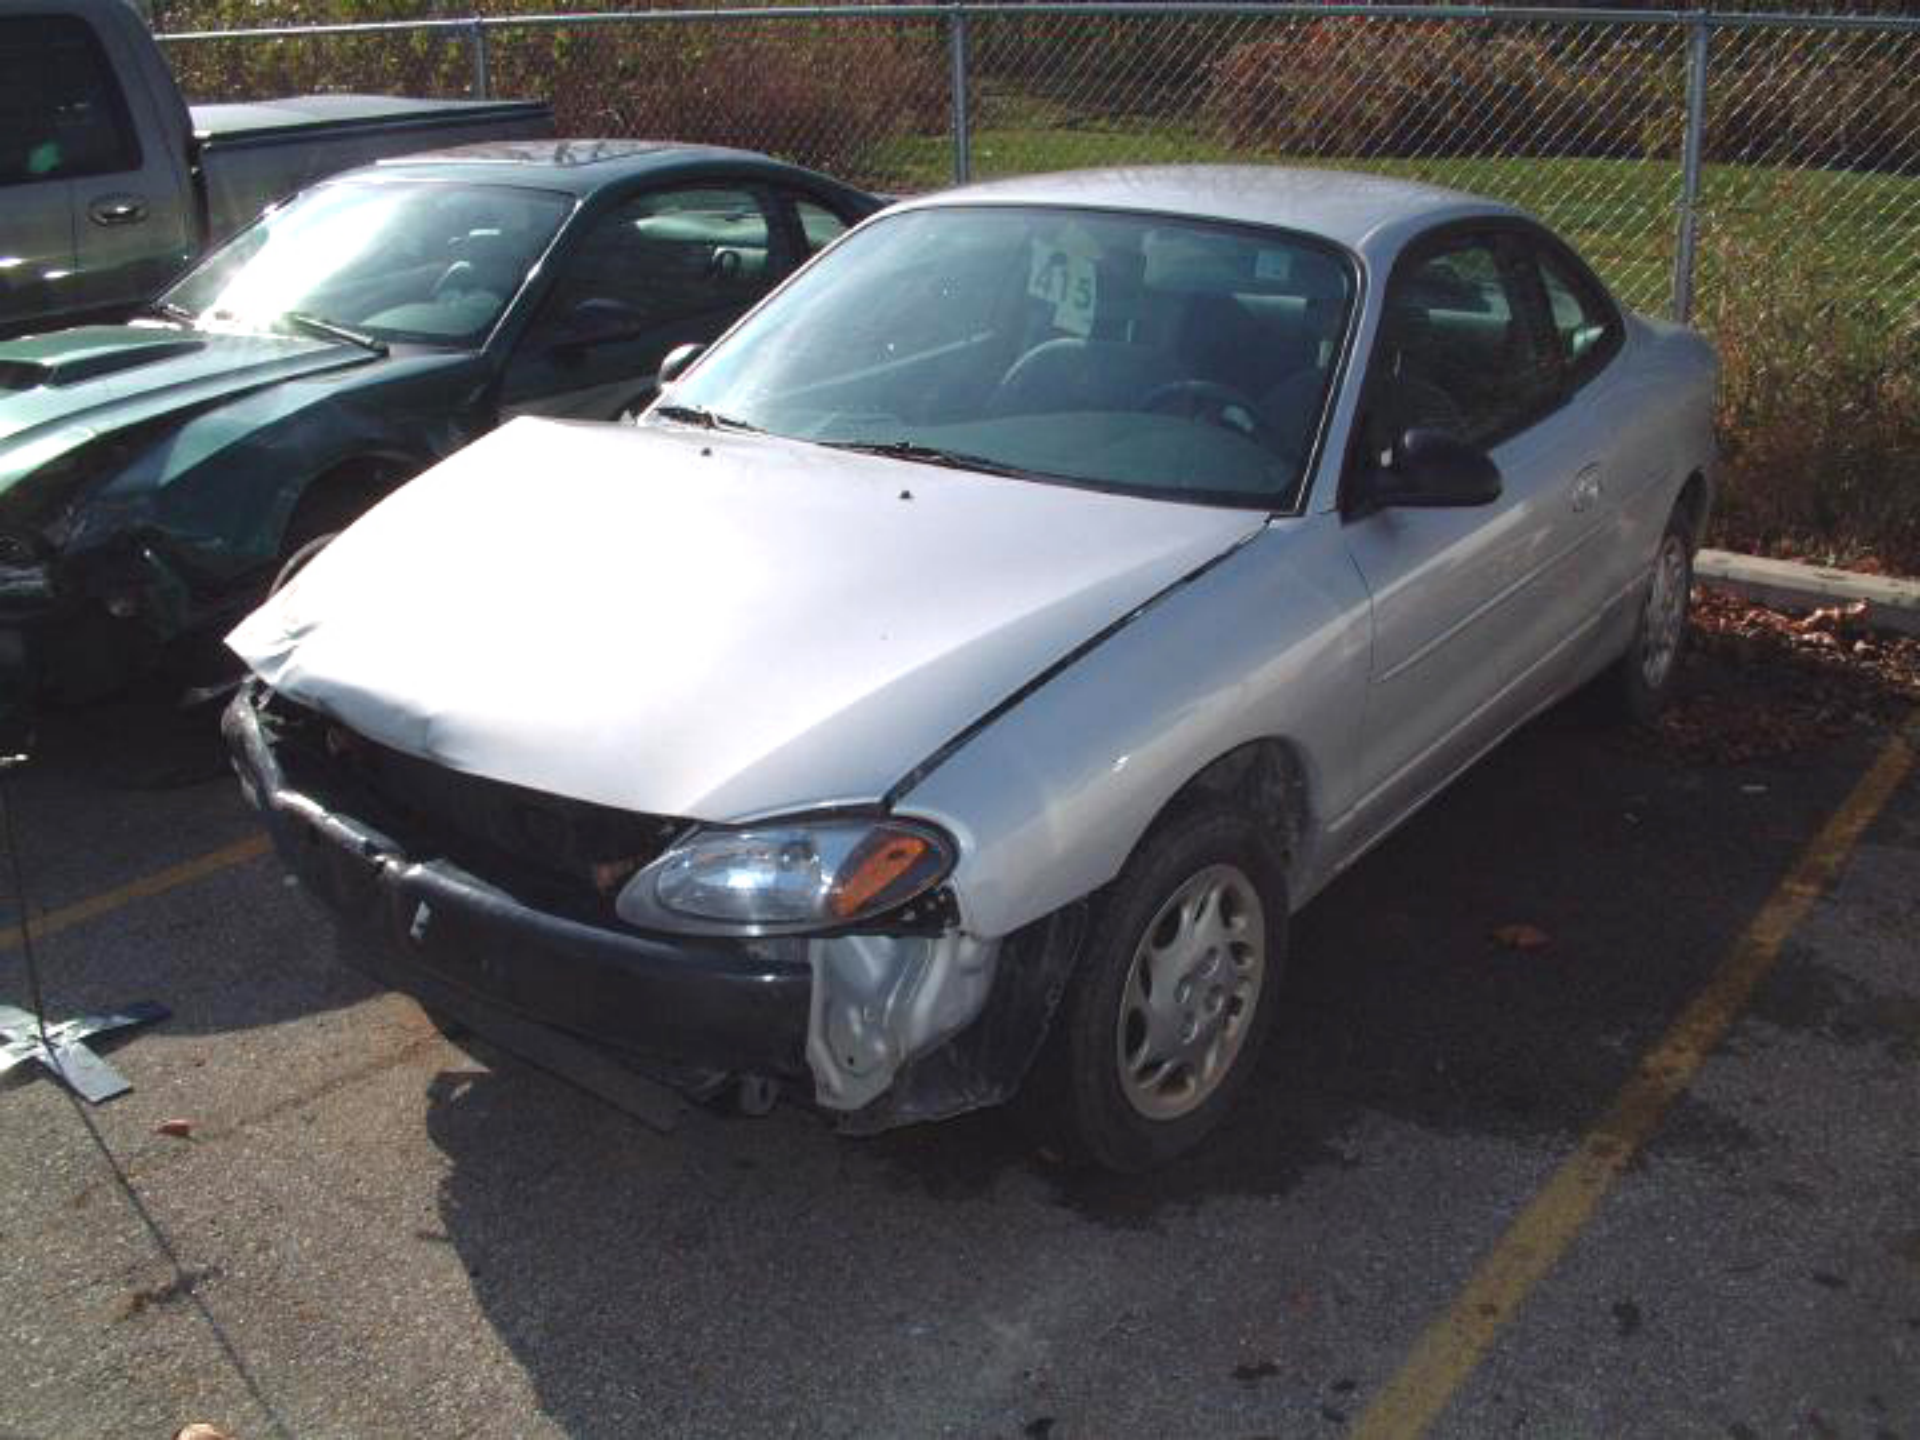
[46](#) The 5-ft, 5-in, 118-lb, 49-year-old female driver was reportedly wearing the three-point belt and the frontal-impact airbag deployed, although [47](#) there were no witness marks on the plastic D-ring to confirm belt use during the crash. The seat was adjusted to a mid-
